**Report on**  
**GEOTECHNICAL STUDY**  
**PROPOSED HERITAGE HILLS STAGE 2**  
**RURAL RESIDENTIAL DEVELOPMENT**  
**LOT 9001 NUNNAGINE CIRCLE, ROELANDS**

**Submitted to:**  
Roelands Development Pty Ltd  
21 Lerici Circle  
BUNBURY WA 6230

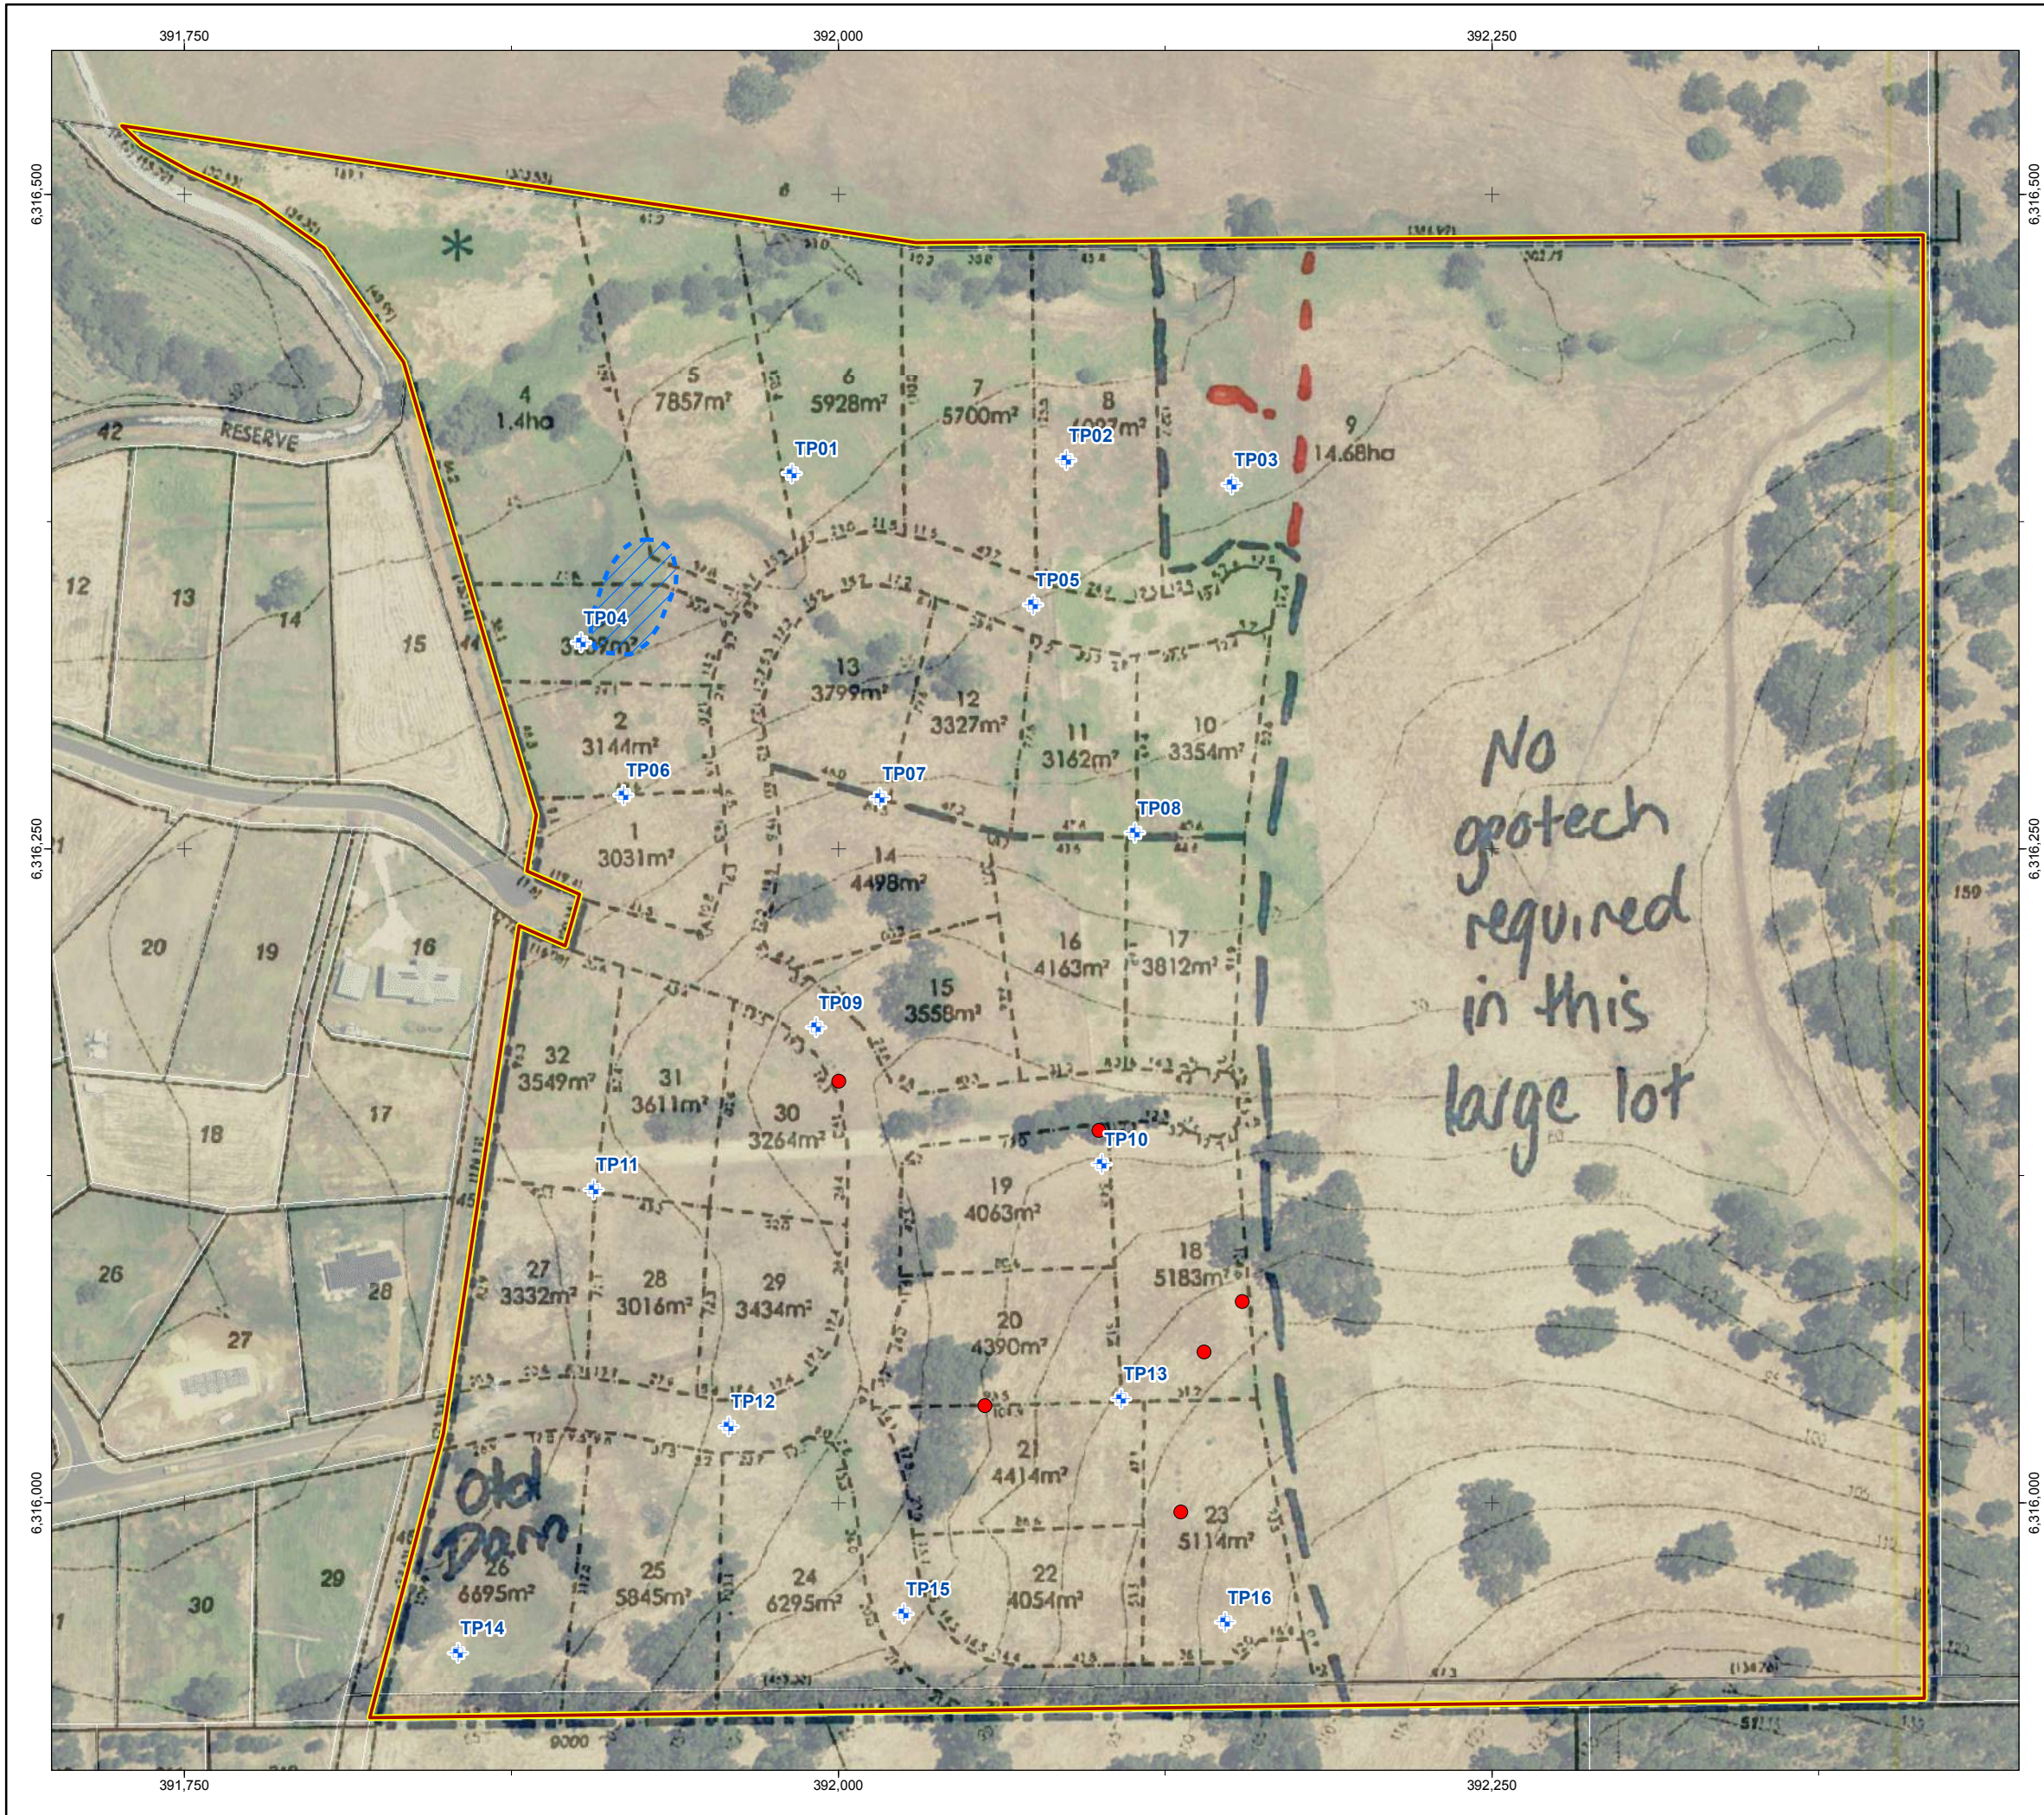
CLIENT	ROELANDS DEVELOPMENT PTY LTD		
PROJECT	GEOTECHNICAL STUDY PROPOSED RURAL RESIDENTIAL DEVELOPMENT		
LOCATION	LOT 9001 NUNNAGINE CIRCLE, ROELANDS		
TITLE	SITE & LOCATION PLAN		
Job No	J1601231	Fig No	FIGURE 1
		Rev	A

This report presents the outcomes of Galt Geotechnics Pty Ltd's (Galt's) geotechnical study for the proposed Heritage Hills Stage 2 rural residential development at Lot 9001 Nunnagine Circle, Roelands (the "site"). The location of the site relative to the surrounding area is shown on Figure 1, Site and Location Plan.

At the time of the study, the site was being used as grazing paddocks, and covered in grasses with occasional trees. We also noted rock outcrop at the surface at a number of locations across the elevated eastern part of the site. The approximate locations of rock outcropping at the surface are shown on Figure 1.

Weathered rock was generally encountered across the higher elevation parts of the site (along the eastern and south eastern parts of the site). We also noted rock outcrop at the surface at a number of locations across the elevated eastern part of the site.

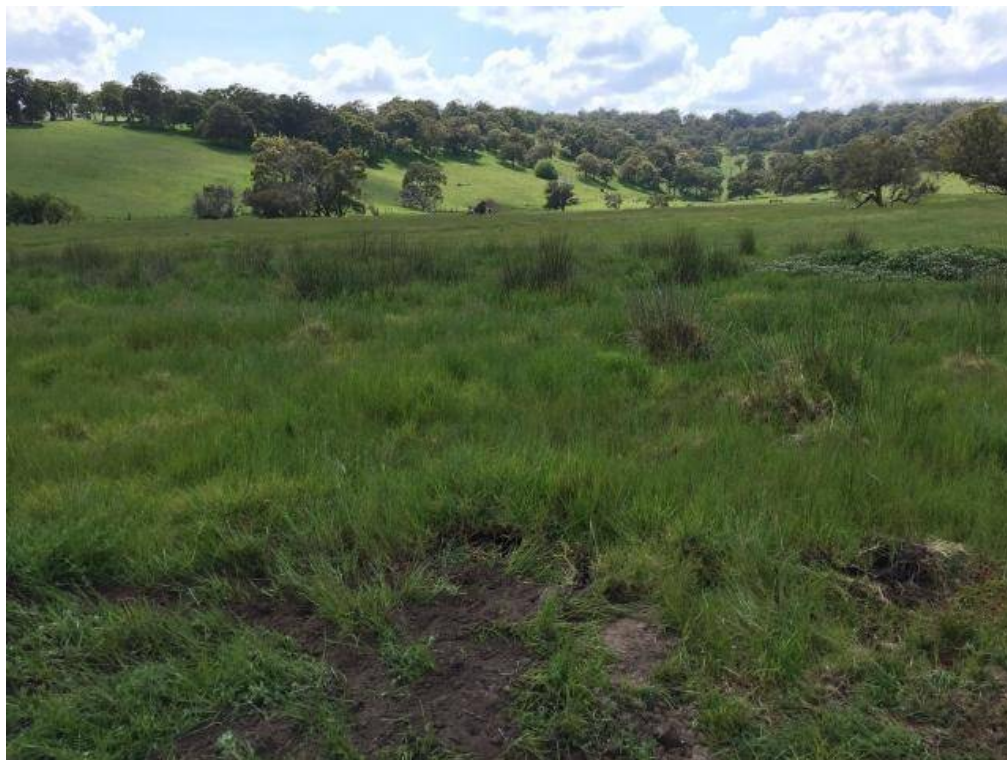
**Photograph 3: Looking at the area where water is ponding at the surface adjacent to TP04**

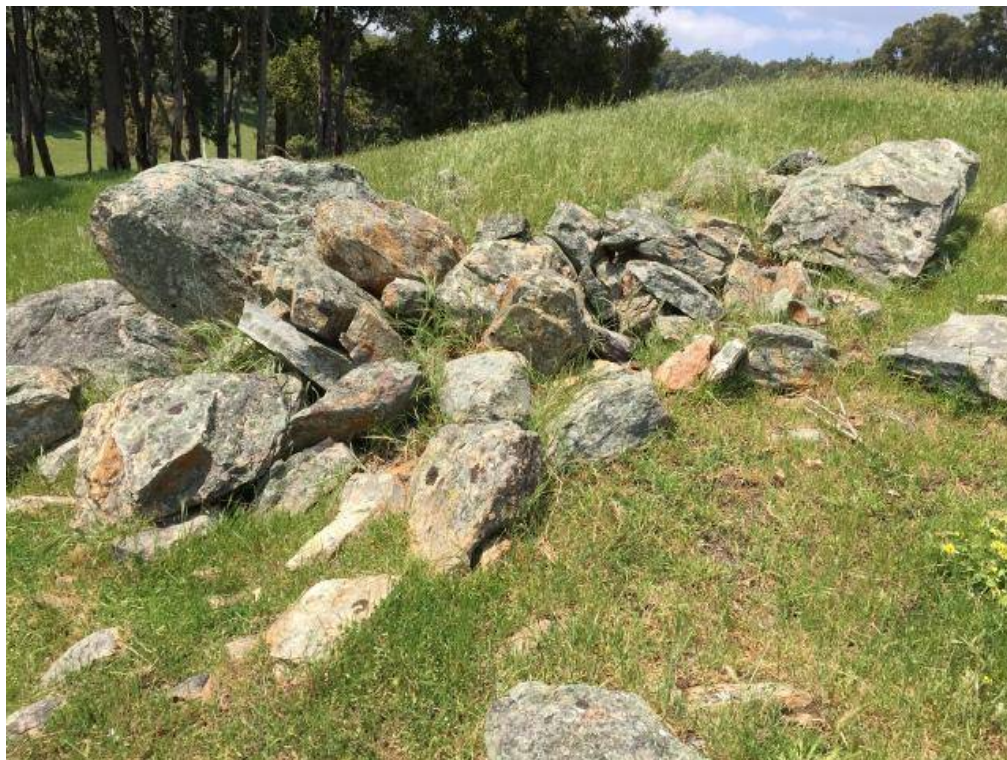
**Photograph 7: View of typical rock outcropping at the surface**

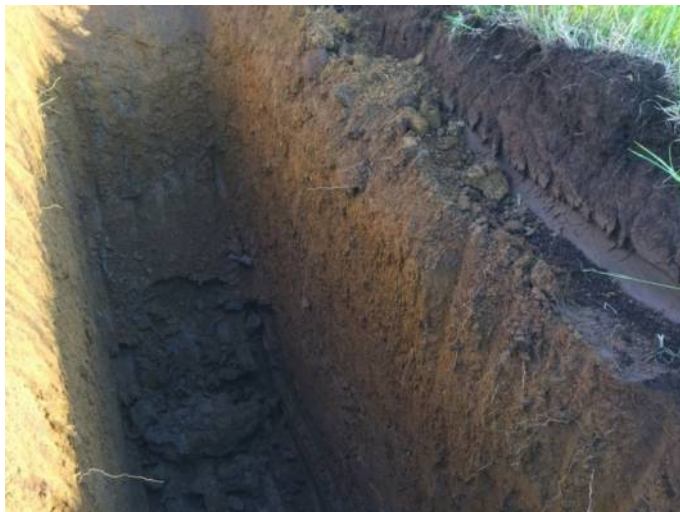
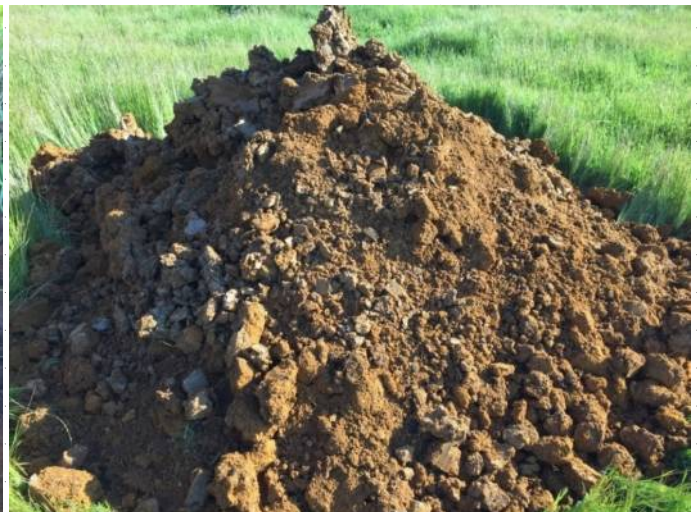
TOPSOIL: Clayey SAND/Silty SAND, brown, with some organics, with some roots	M	F - St		
			CI				Sandy CLAY: low to medium plasticity, brown becoming brown/orange, trace roots						
			CI / CH				Clayey SAND/Sandy CLAY: medium to high plasticity, orange/brown/grey, trace gravel, trace roots						
			CI / CH				Sandy CLAY/Gravelly CLAY: medium to high plasticity, orange/brown/grey, gravel is weathered rock						
			CI / CH				CLAY: medium to high plasticity, orange/brown/grey, with some sand and gravel						
	F		2.0						Hole terminated at 2.00 m Target depth Groundwater not encountered

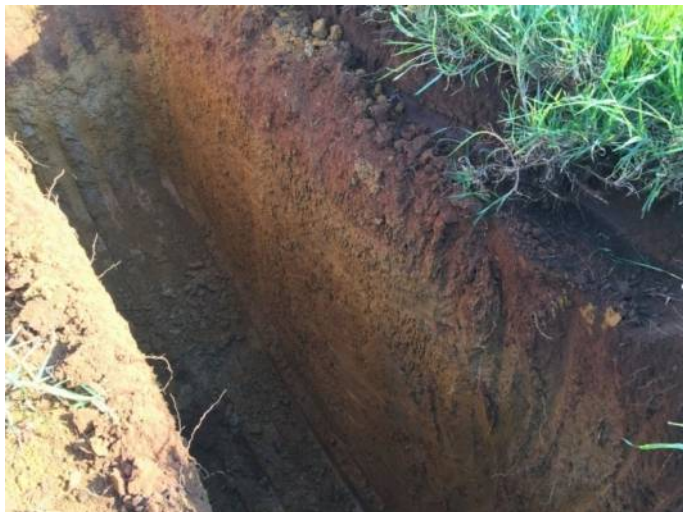
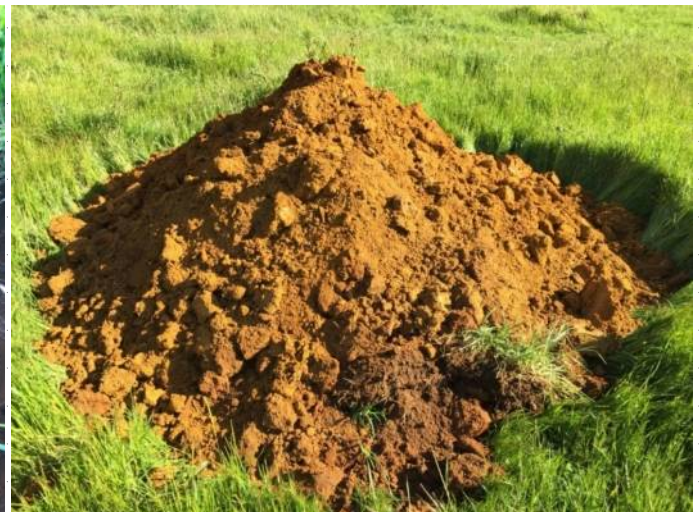
Excavation					Sampling		Field Material Description					
METHOD	EXCAVATION RESISTANCE	WATER	DEPTH (metres)	DEPTH RL	SAMPLE OR FIELD TEST	RECOVERED	GRAPHIC LOG	USCS SYMBOL	SOIL/ROCK MATERIAL DESCRIPTION	MOISTURE CONDITION	CONSISTENCY DENSITY	STRUCTURE AND ADDITIONAL OBSERVATIONS
E	E		0.0		B(TP02-01)				TOPSOIL: Clayey SAND/Silty SAND, brown, with some organics, with some roots	M	F - St	
	F						CI	Sandy CLAY: low to medium plasticity, red/brown, trace organics, trace roots				
							CI	Sandy CLAY: low to medium plasticity, orange/brown/grey, with some gravel				
							CI / CH	Sandy CLAY: medium to high plasticity, orange/brown/grey, trace gravel				
							CI / CH	CLAY: medium to high plasticity, orange/brown/red/grey, with some sand, trace gravel				
						Hole terminated at 2.00 m Target depth Groundwater not encountered

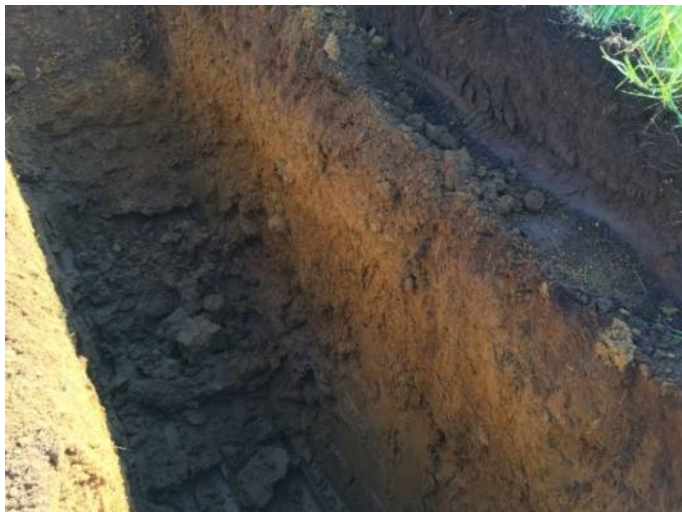
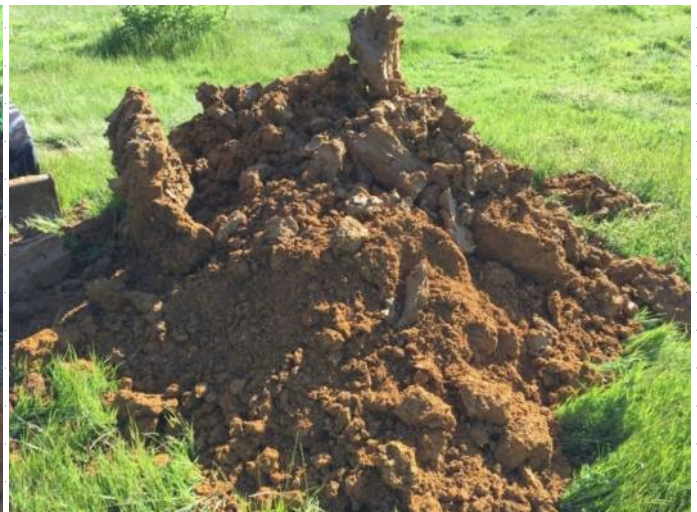
CI	TOPSOIL: Clayey SAND/Silty SAND, brown, with some organics, with some roots	M	F - St		
	0.5		Sandy CLAY: low to medium plasticity, orange/brown, with some gravel ----- Grading into Sandy CLAY									
	1.0		Sandy CLAY: medium to high plasticity, orange/brown/grey, with some gravel ----- Grading into CLAY									
	1.5		CLAY: medium to high plasticity, orange/brown/grey, trace gravel									
	2.0		Hole terminated at 2.00 m Target depth Groundwater not encountered

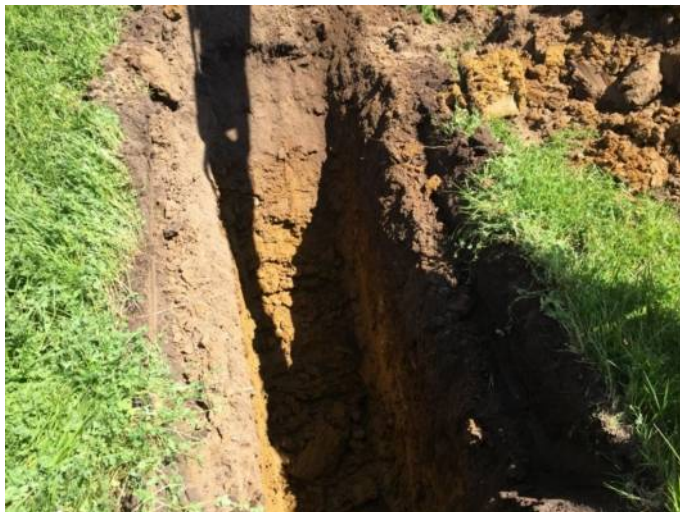
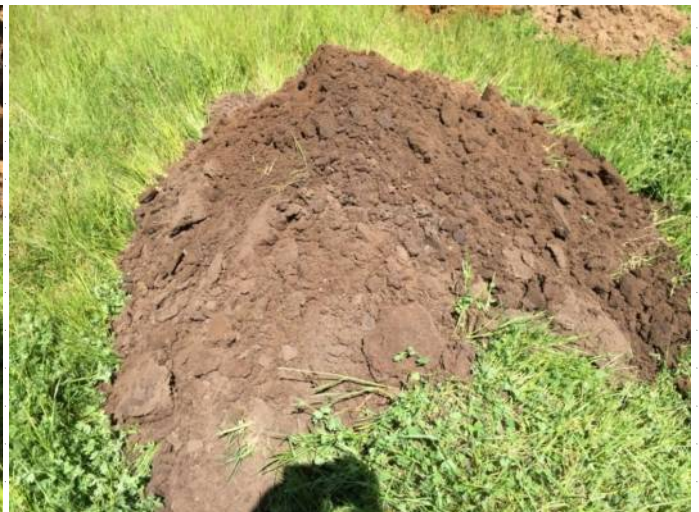
Excavation					Sampling		Field Material Description						
METHOD	EXCAVATION RESISTANCE	WATER	DEPTH (metres)	DEPTH RL	SAMPLE OR FIELD TEST	RECOVERED	GRAPHIC LOG	USCS SYMBOL	SOIL/ROCK MATERIAL DESCRIPTION	MOISTURE CONDITION	CONSISTENCY	DENSITY	STRUCTURE AND ADDITIONAL OBSERVATIONS
E	E		0.0						TOPSOIL: Clayey SAND/Silty SAND brown, with some organics, with some roots	M	F - St		Water ponding on surface 10 m to the east.
							Silty SAND/Clayey SAND/ Sandy CLAY: fine to medium grained, grey mottled brown						
	0.5		B(TP04-01)			SM / SC	Sandy CLAY: medium to high plasticity, orange/brown/grey						
	1.0					CI / CH	CLAY: medium to high plasticity, orange/brown, trace sand and gravel						
	F			1.5	B(TP04-02)			CI / CH					
			2.0						Hole terminated at 2.00 m Target depth Groundwater not encountered

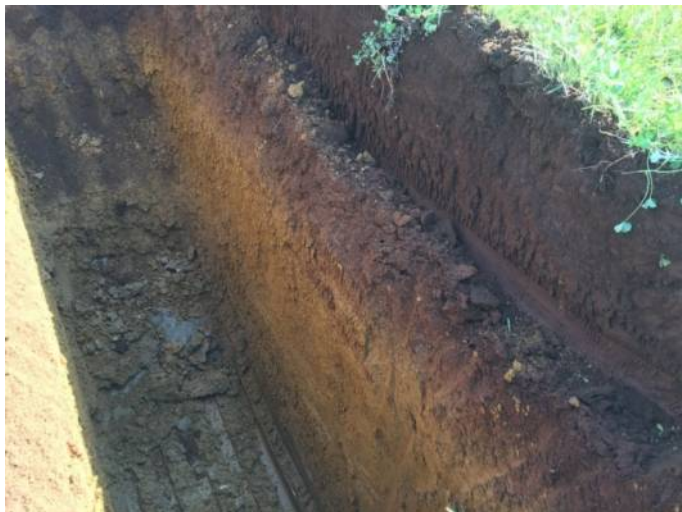
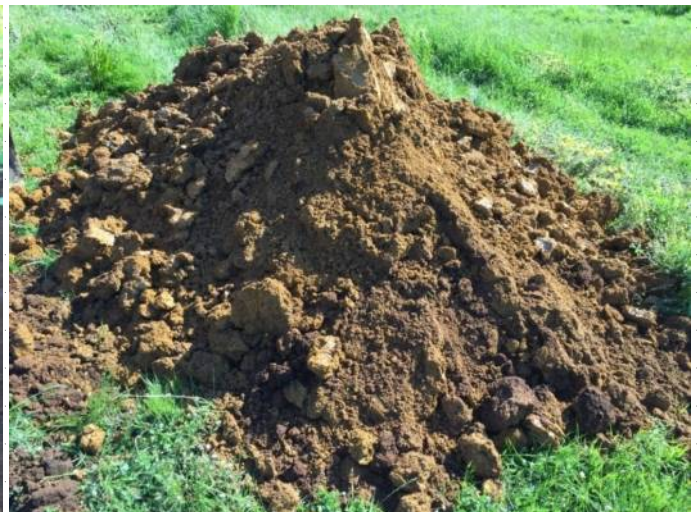
Sandy CLAY: medium plasticity, orange/brown mottled grey, fine to medium grained sand, with some gravel					
			B(TP05-02)				CI	Decreasing gravel content					
							CI / CH	CLAY: medium to high plasticity, grey/brown with dark grey veins, trace gravel					
	F		1.0						M				
			1.5								St		
			2.0						Hole terminated at 2.00 m Target depth Groundwater not encountered

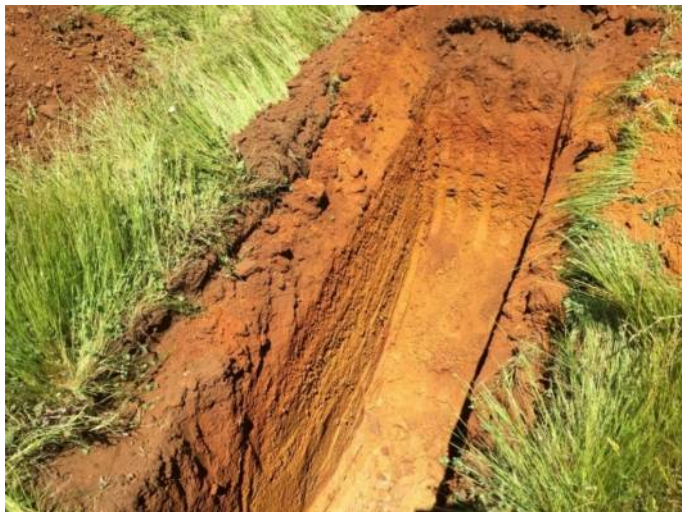
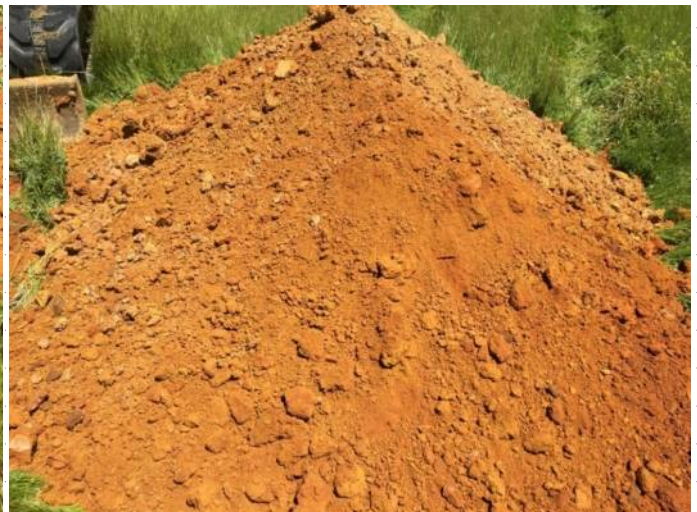
2.0						Hole terminated at 2.00 m Target depth Groundwater not encountered

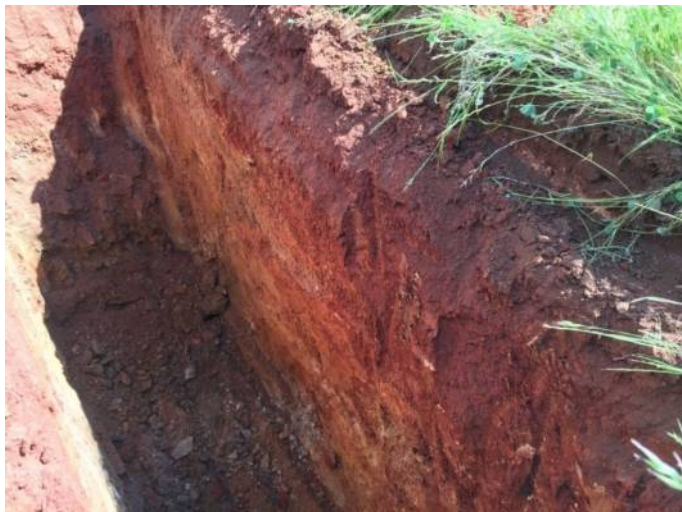
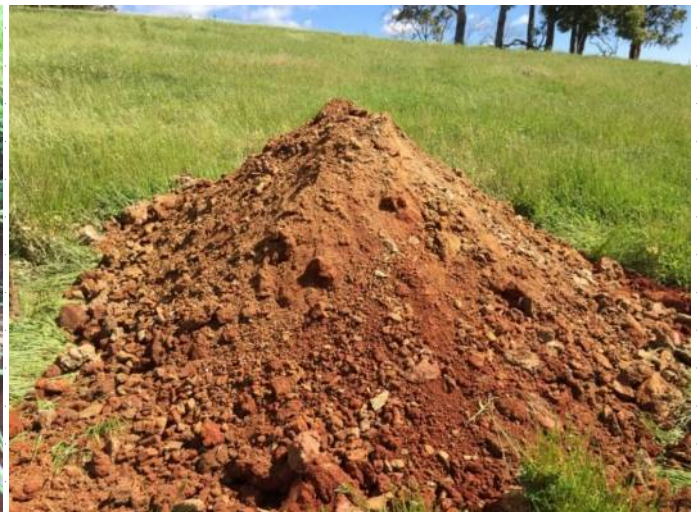
Excavation					Sampling		Field Material Description					
METHOD	EXCAVATION RESISTANCE	WATER	DEPTH (metres)	DEPTH RL	SAMPLE OR FIELD TEST	RECOVERED	GRAPHIC LOG	USCS SYMBOL	SOIL/ROCK MATERIAL DESCRIPTION	MOISTURE CONDITION	CONSISTENCY DENSITY	STRUCTURE AND ADDITIONAL OBSERVATIONS
E			0.0						TOPSOIL: Clayey SAND/Silty SAND, brown, with some organics, with some roots, with some gravel			
	H								Sandy CLAY: medium to high plasticity, red/brown, with some gravel			
			0.5		B(TP07-01)			Cl / CH		M	St	
	F							Cl / CH	Gravelly CLAY/Clayey GRAVEL: medium to high plasticity, red/brown			
			1.0						WEATHERED ROCK: recovered as Clayey GRAVEL/Silty GRAVEL, grey/brown/dark grey, with fragments of rock (slightly weathered to highly weathered)			
	H		1.5									
	VH											
			2.0						Hole terminated at 1.80 m Refusal Groundwater not encountered

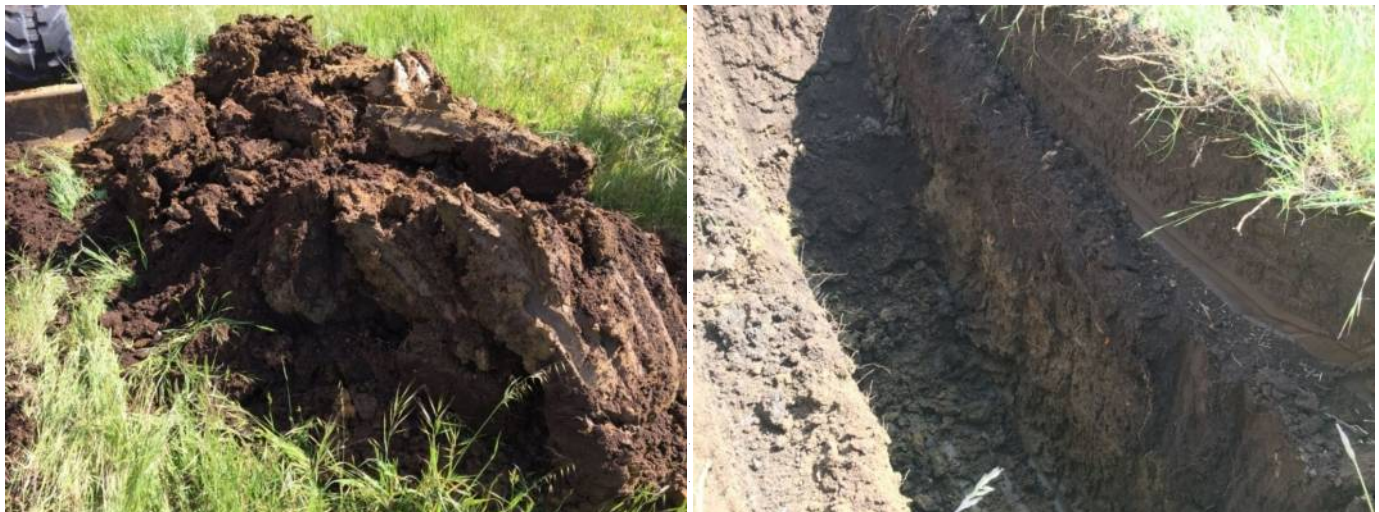
CI	TOPSOIL: Peaty SAND/Clayey SAND, brown, with organics, trace roots				
			Sandy CLAY with organics: low to medium plasticity, brown, with some rock									
	F		CI / CH				CLAY/Sandy CLAY: medium to high plasticity, brown/orange/grey, trace roots					
							Grading into CLAY					
			CI / CH				CLAY: medium to high plasticity, grey/brown/dark grey, with some sand and gravel					
		Hole terminated at 2.00 m Target depth Groundwater not encountered

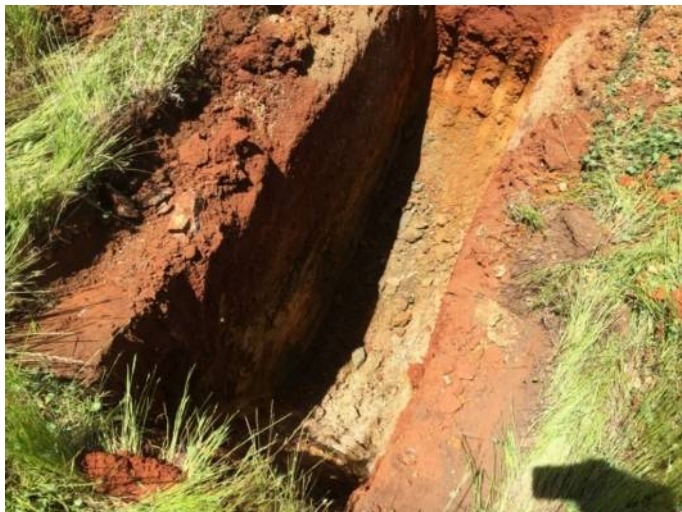
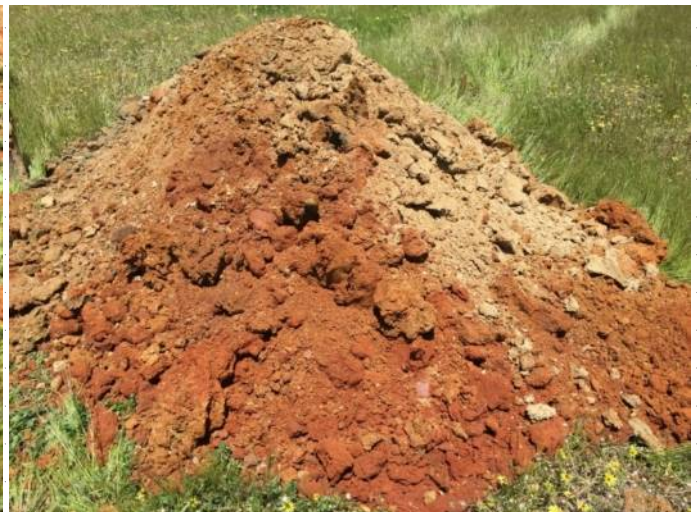
CI / CH	TOPSOIL: Clayey SAND/Silty SAND, fine to medium grained, brown, with some organics and roots	M	St	Rock outcrops nearby		
			Sandy CLAY: medium to high plasticity, red/brown, trace gravel										
	F		CLAY/Sandy CLAY: medium to high plasticity, orange/red/brown, trace gravel										
	H		WEATHERED ROCK: recovered as Silty GRAVEL/Clayey GRAVEL, grey/dark grey, with fragments of rock (slightly weathered)										
	VH		Increasing rock fragments (slightly weathered)										
			2.0					Hole terminated at 1.80 m Refusal Groundwater not encountered

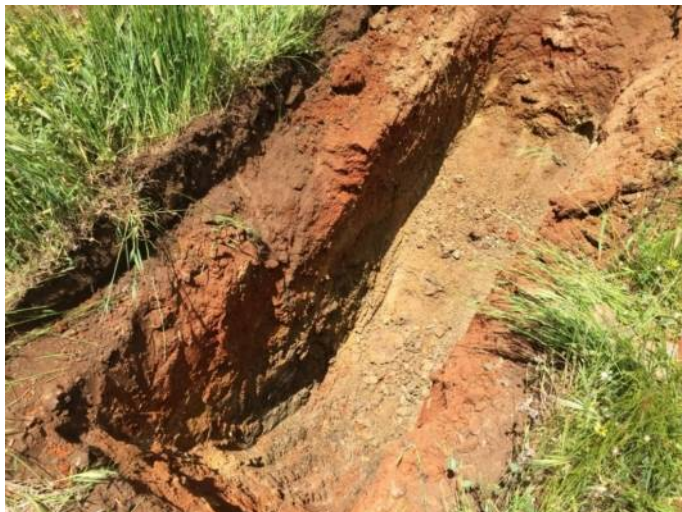
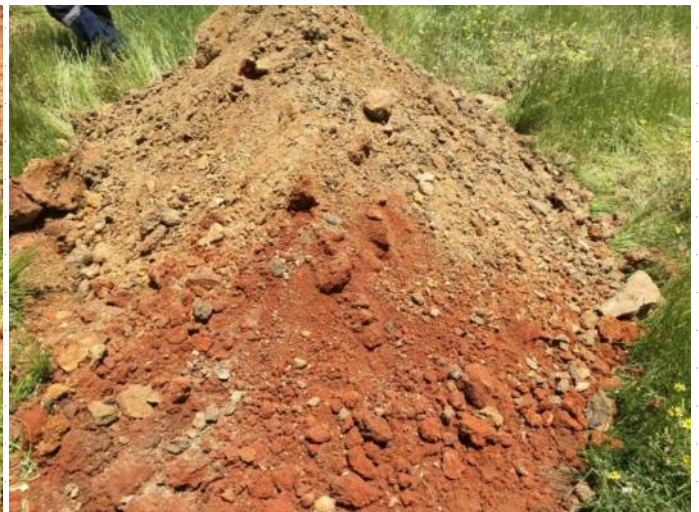
Excavation					Sampling		Field Material Description				
METHOD	EXCAVATION RESISTANCE	WATER	DEPTH (metres)	DEPTH RL	SAMPLE OR FIELD TEST	RECOVERED GRAPHIC LOG	USCS SYMBOL	SOIL/ROCK MATERIAL DESCRIPTION	MOISTURE CONDITION	CONSISTENCY	STRUCTURE AND ADDITIONAL OBSERVATIONS
E	E		0.0					TOPSOIL: Clayey SAND/Silty SAND, fine to medium grained, brown, with some organics, with some roots			Rock outcrops nearby
	F		0.5		B(TP10-01)		CI / CH	Sandy CLAY: medium to high plasticity, red/brown, trace gravel	M	F - St	
	H		1.0					WEATHERED ROCK: recovered as Silty GRAVEL/Clayey GRAVEL, grey/brown/dark grey, with fragments of rock (slightly weathered to highly weathered)			
			1.5		B(TP10-02)			Increasing rock fragments (slightly weathered)			
	VH		2.0					Hole terminated at 1.80 m Refusal Groundwater not encountered

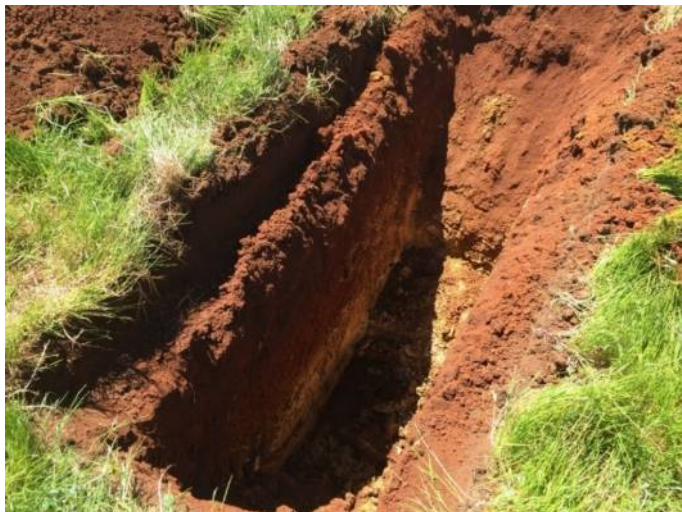
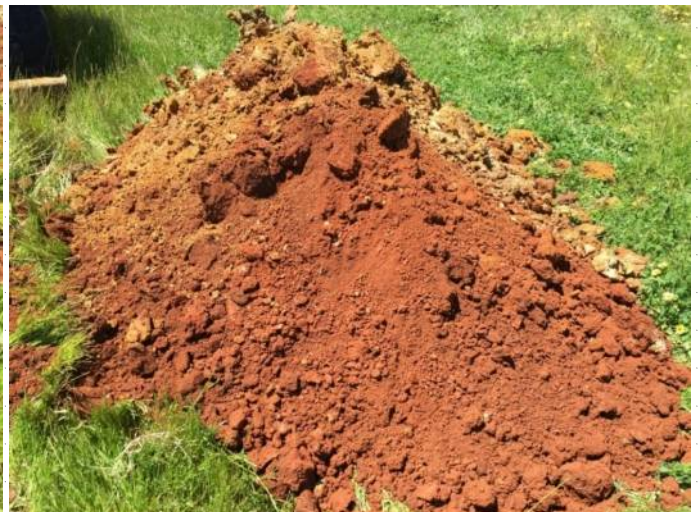
Excavation					Sampling		Field Material Description				
METHOD	EXCAVATION RESISTANCE	WATER	DEPTH (metres)	DEPTH RL	SAMPLE OR FIELD TEST	RECOVERED	GRAPHIC LOG	USCS SYMBOL	SOIL/ROCK MATERIAL DESCRIPTION	MOISTURE CONDITION	STRUCTURE AND ADDITIONAL OBSERVATIONS
E	F		0.0						TOPSOIL: Clayey SAND/Silty SAND, fine to medium grained, brown, with some organics, with some roots		
			0.5		B(TP11-01)				Sandy CLAY: medium to high plasticity, brown/red, trace roots		
			1.0		B(TP11-02)			CI / CH	Becoming red/brown, trace gravel, no roots	M	F - St
			1.5					CI / CH	Sandy CLAY/Gravelly CLAY: medium to high plasticity, orange/red/brown		
			2.0		B(TP11-03)			CI / CH	CLAY: medium to high plasticity, grey/brown		
									Hole terminated at 2.00 m Target depth Groundwater not encountered

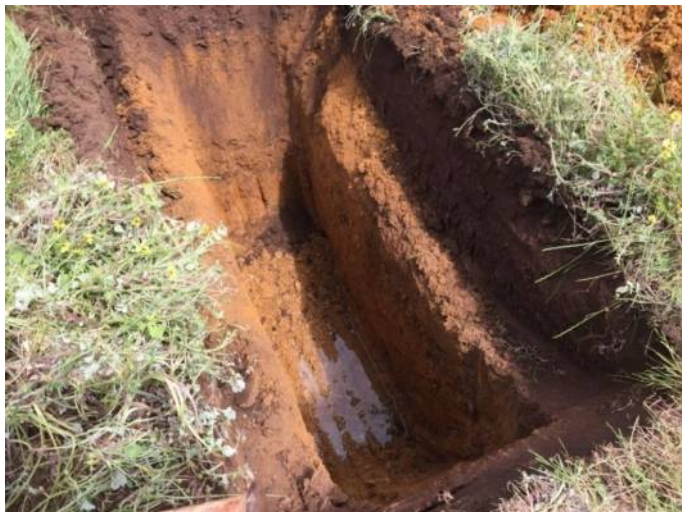
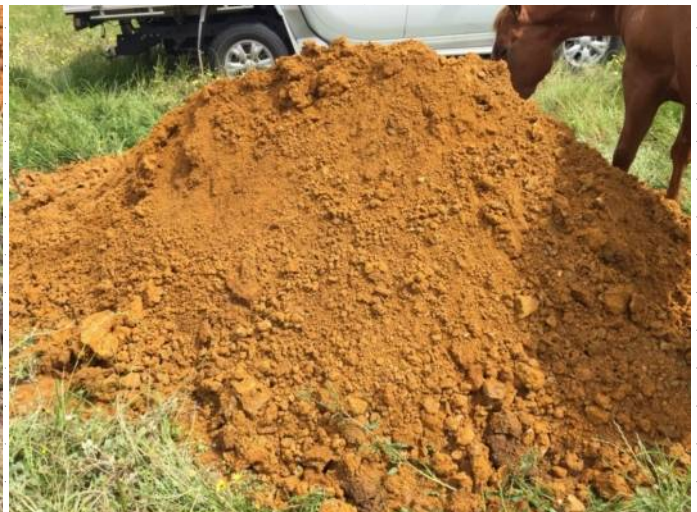
TOPSOIL: Clayey SAND/Silty SAND, fine to medium grained, brown, with some organics, with some roots	M	F - St	
	F		B(TP12-01)			CI	Sandy CLAY: low to medium plasticity, brown, trace organics and roots					
						CI	Sandy CLAY: low to medium plasticity, brown/orange					
						CI / CH	Gravelly CLAY: medium to high plasticity, brown/orange, with fragments of rock up to 100 mm diameter					
	H		B(TP12-02)			CI / CH	Sandy CLAY/Gravelly CLAY: medium to high plasticity, orange/brown, with fragments of rock (slightly weathered to highly weathered)	VSt - H				
									Hole terminated at 2.20 m Target depth Groundwater slow seepage at 1.8 m

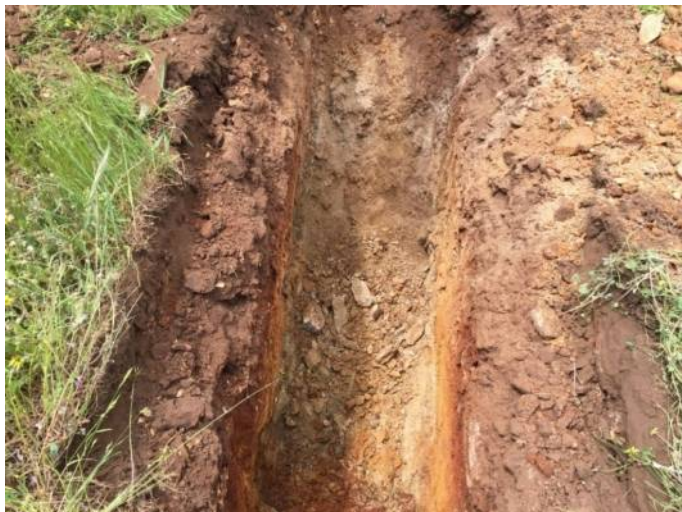
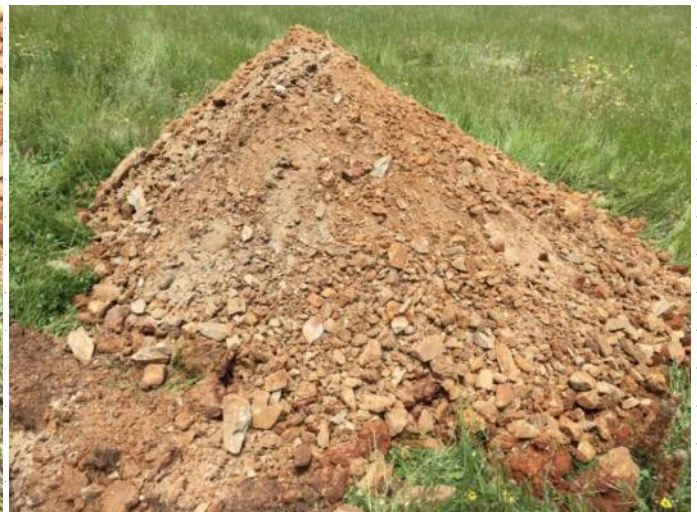
Excavation					Sampling		Field Material Description						
METHOD	EXCAVATION RESISTANCE	WATER	DEPTH (metres)	DEPTH RL	SAMPLE OR FIELD TEST	RECOVERED	GRAPHIC LOG	USCS SYMBOL	SOIL/ROCK MATERIAL DESCRIPTION		MOISTURE CONDITION	CONSISTENCY DENSITY	STRUCTURE AND ADDITIONAL OBSERVATIONS
E	E		0.0		B(TP13-01)			CI	TOPSOIL: Clayey SAND/Silty SAND, brown, with some organics, with some roots	M	F - St	Rock outcrop nearby	
	F						Sandy CLAY: low to medium plasticity, orange/brown, with some gravel						
							Sandy CLAY: low to medium plasticity, red/brown, with some gravel						
							Sandy CLAY: medium to high plasticity, orange/brown, with some gravel						
							CI / CH		Increasing gravel content and rock fragments (highly weathered)				
VH		WEATHERED ROCK: recovered as Silty GRAVEL/Clayey GRAVEL, grey/brown/dark grey, with fragments of rock (Slightly weathered to highly weathered)

2.0						Hole terminated at 1.60 m Refusal on rock Groundwater not encountered

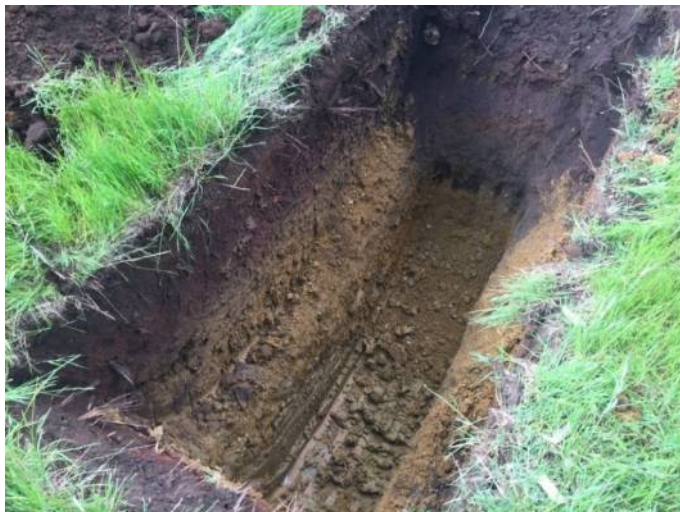
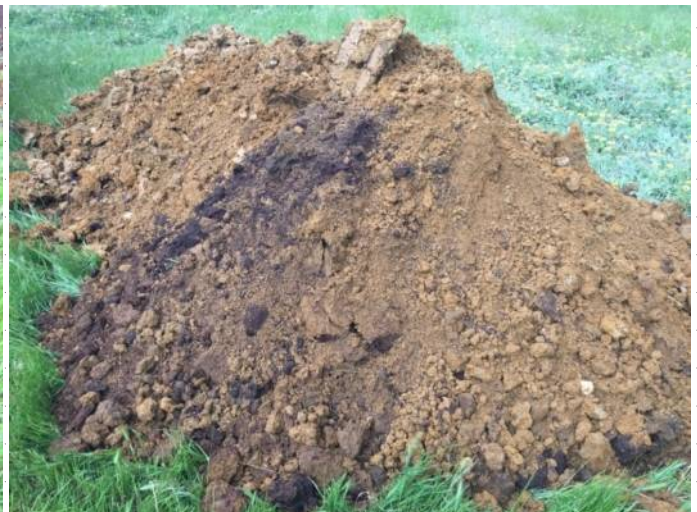
CI / CH	Sandy CLAY: medium to high plasticity, orange/brown, with some gravel	F - St	M		
	1.5							Increasing gravel content				
	2.0				CLAY: medium to high plasticity, orange/brown mottled grey	St						
									Hole terminated at 2.20 m Target depth Groundwater very slow seepage at 1.2 m

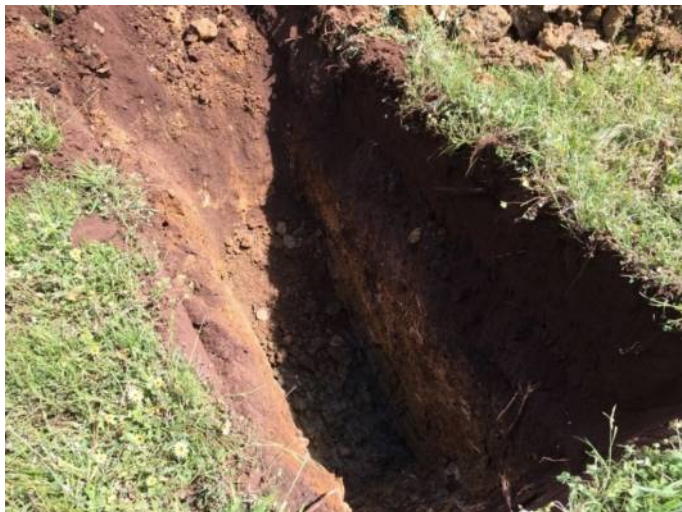
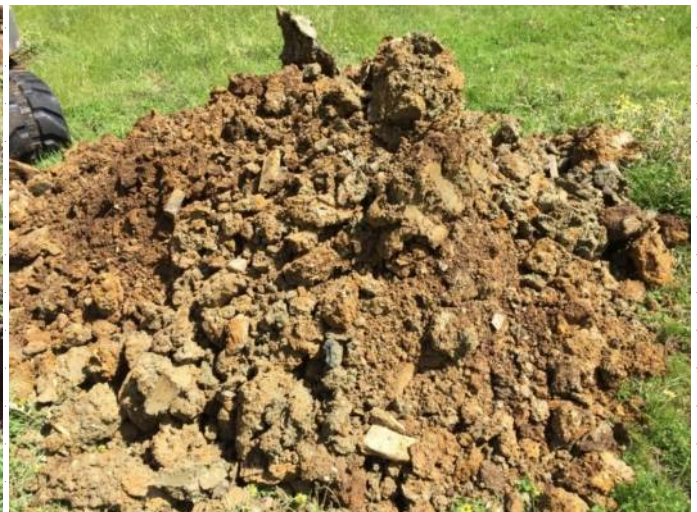
Excavation					Sampling		Field Material Description					
METHOD	EXCAVATION RESISTANCE	WATER	DEPTH (metres)	DEPTH RL	SAMPLE OR FIELD TEST	RECOVERED	GRAPHIC LOG	USCS SYMBOL	SOIL/ROCK MATERIAL DESCRIPTION	MOISTURE CONDITION	CONSISTENCY DENSITY	STRUCTURE AND ADDITIONAL OBSERVATIONS
E	E		0.0						TOPSOIL: Clayey SAND/Silty SAND, fine to medium grained, brown, with some organics, with some roots	M	F - St	Root at 0.7 m, 30 mm diameter
	F		B(TP15-01)				CI	Sandy CLAY/Clayey SAND: low to medium plasticity, brown, trace organics, trace roots				
							CI	Sandy CLAY: low to medium plasticity, brown/grey				
			B(TP15-02)				CI / CH	Gravelly CLAY: medium to high plasticity, orange/brown mottled grey, with fragments of rock (slightly weathered)				
								Decreasing gravel content				
				CH	CLAY: medium to high plasticity, grey mottled orange/brown mottled grey	VSt						
								Hole terminated at 2.20 m Target depth Groundwater not encountered

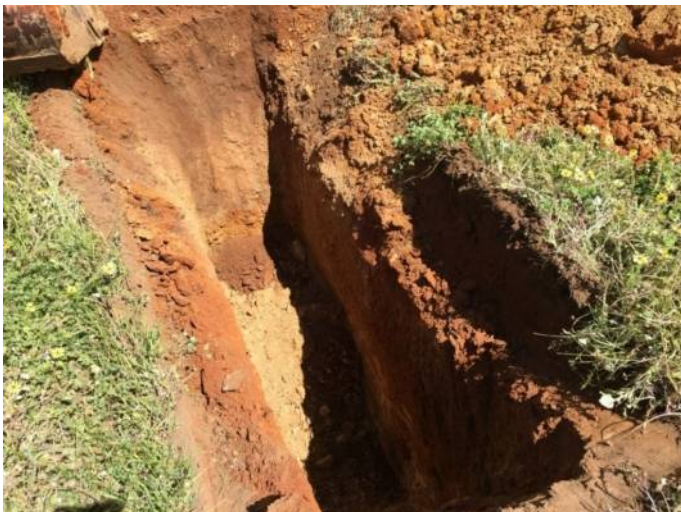
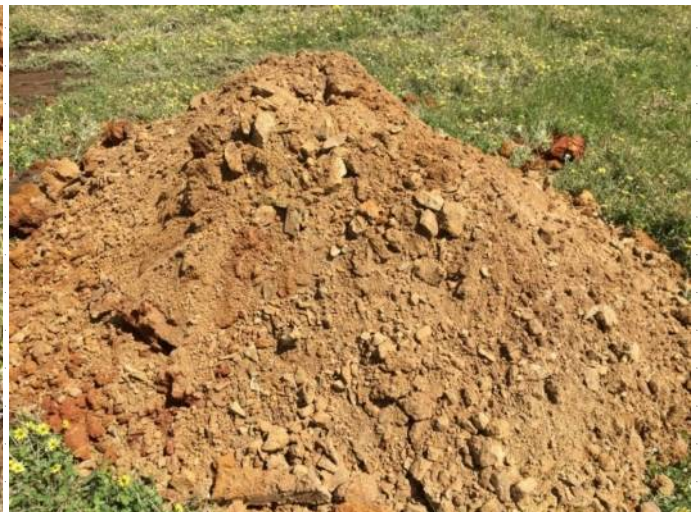
TOPSOIL: Clayey SAND/Silty SAND, fine to medium grained, brown, with some organics and roots	M	F - St	
	F		0.5			CI	Sandy CLAY: low to medium plasticity, red/brown, trace gravel	D			
							Sandy CLAY: medium to high plasticity, red/brown, trace gravel				
						CI / CH	Becoming orange/red/brown, with some gravel				
	H		2.0				WEATHERED ROCK: recovered as Silty GRAVEL/Clayey GRAVEL, grey/brown/dark grey, with fragments of rock (slightly weathered to highly weathered)		St		
								Hole terminated at 2.20 m Target depth Groundwater not encountered

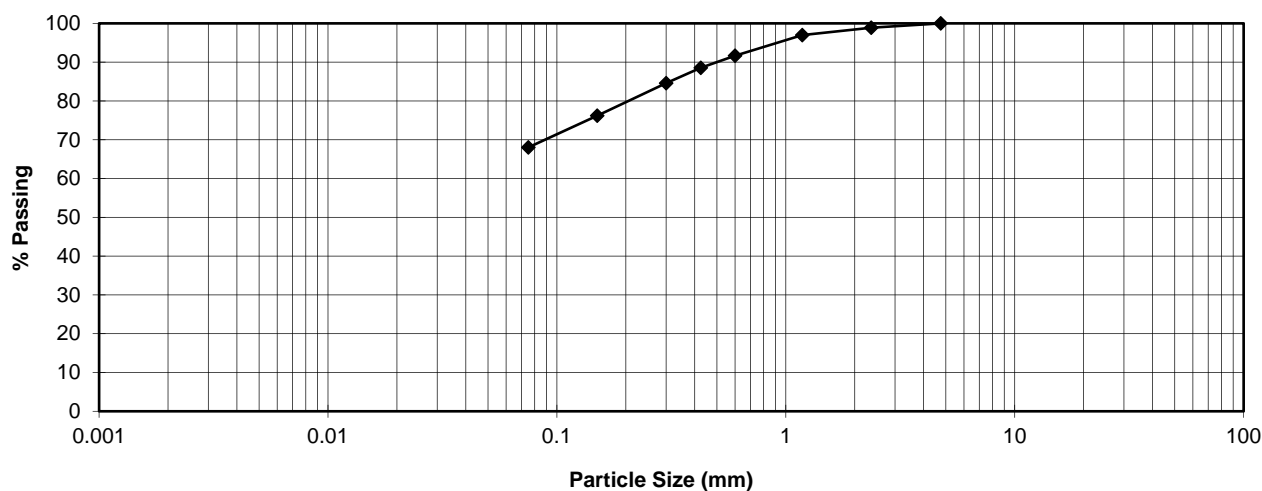
Sample Details: TP05  
Sample Depth (m): 0.3-0.5

## SIEVE ANALYSIS AS1289.3.6.1

Sieve Size (mm)	% Passing
75.0	
37.5	
19.0	
9.5	
4.75	100
2.36	99
1.18	97
0.600	92
0.425	89
0.300	85
0.150	76
0.075	68

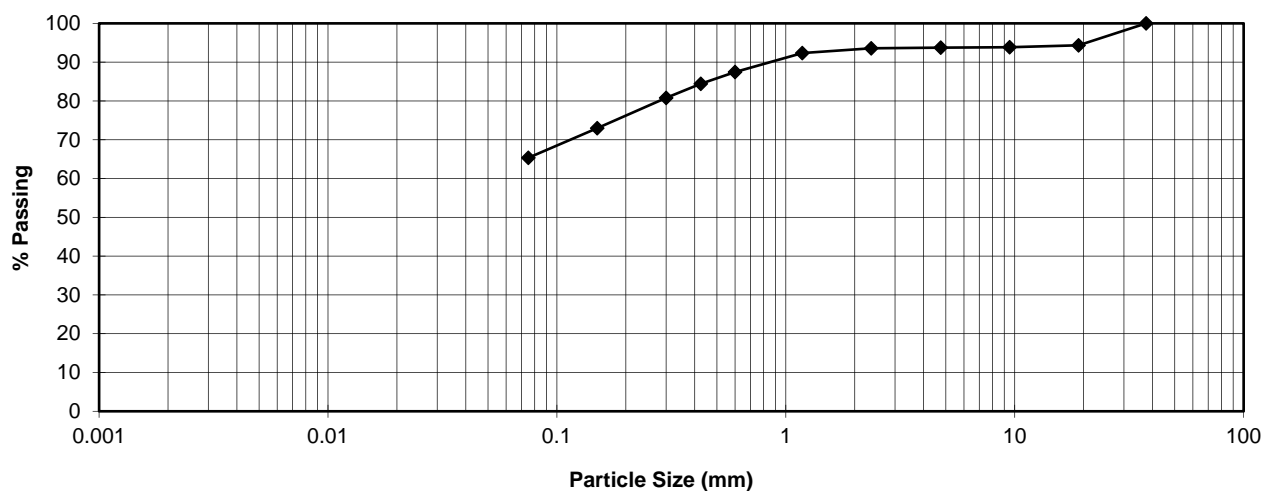
**Sample Details** TP08  
**Sample Depth (m)** 0.3-0.4

### SIEVE ANALYSIS AS1289.3.6.1

Sieve Size (mm)	% Passing
75.0	
37.5	100
19.0	94
9.5	94
4.75	94
2.36	94
1.18	92
0.600	87
0.425	84
0.300	81
0.150	73
0.075	65

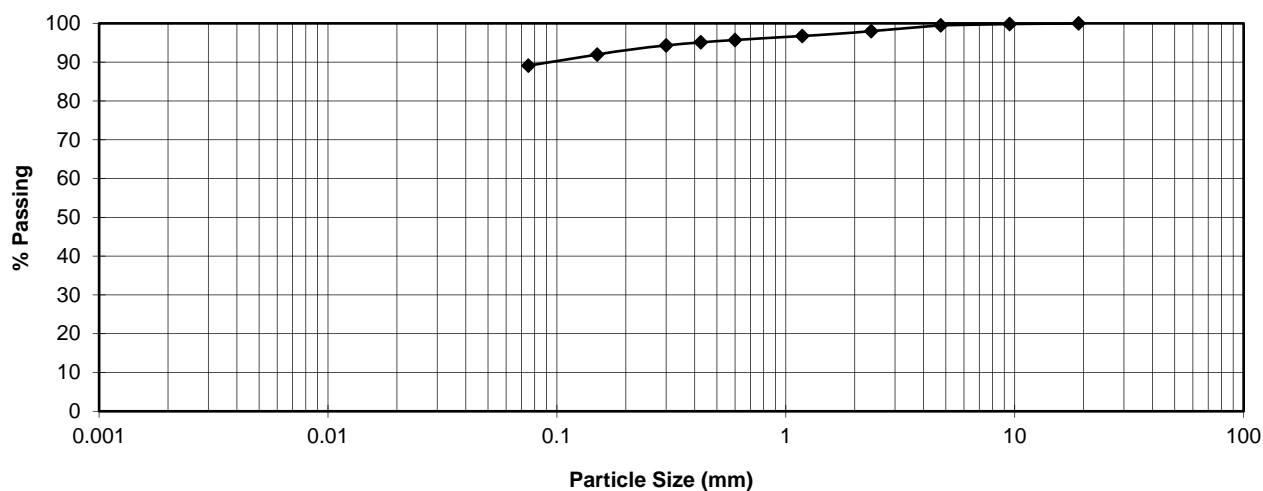
Sample Details: TP09  
Sample Depth (m): 0.4-0.5

## SIEVE ANALYSIS AS1289.3.6.1

Sieve Size (mm)	% Passing
75.0	
37.5	
19.0	100
9.5	100
4.75	99
2.36	98
1.18	97
0.600	96
0.425	95
0.300	94
0.150	92
0.075	89

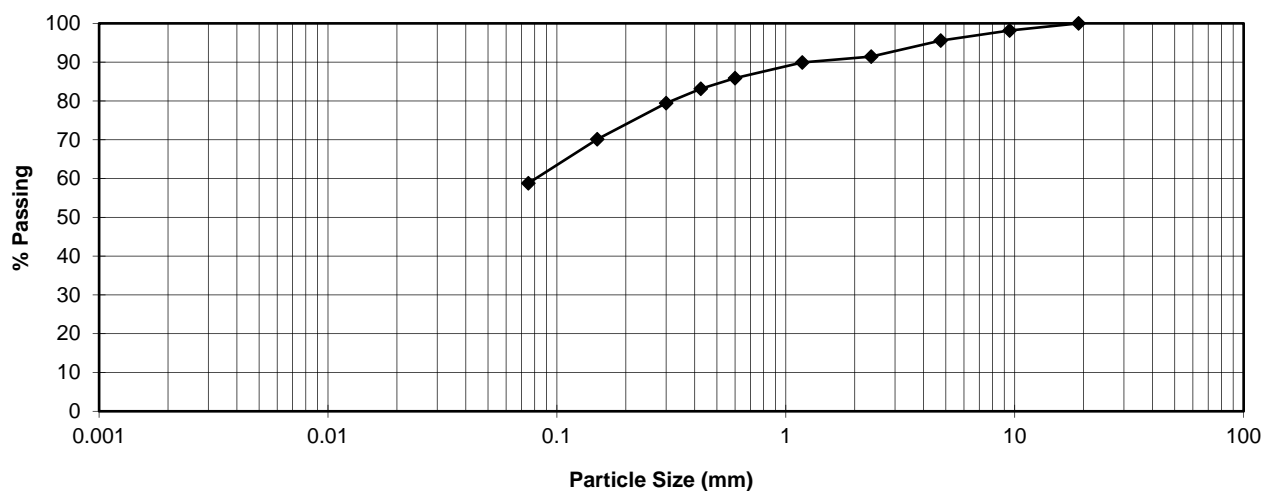
Sample Details: TP12  
Sample Depth (m): 0.4-0.5

## SIEVE ANALYSIS AS1289.3.6.1

Sieve Size (mm)	% Passing
75.0	
37.5	
19.0	100
9.5	98
4.75	96
2.36	91
1.18	90
0.600	86
0.425	83
0.300	79
0.150	70
0.075	59
